# Patent™ zirconia implant system

## A case report

Dr Sebastian Horvath, Germany

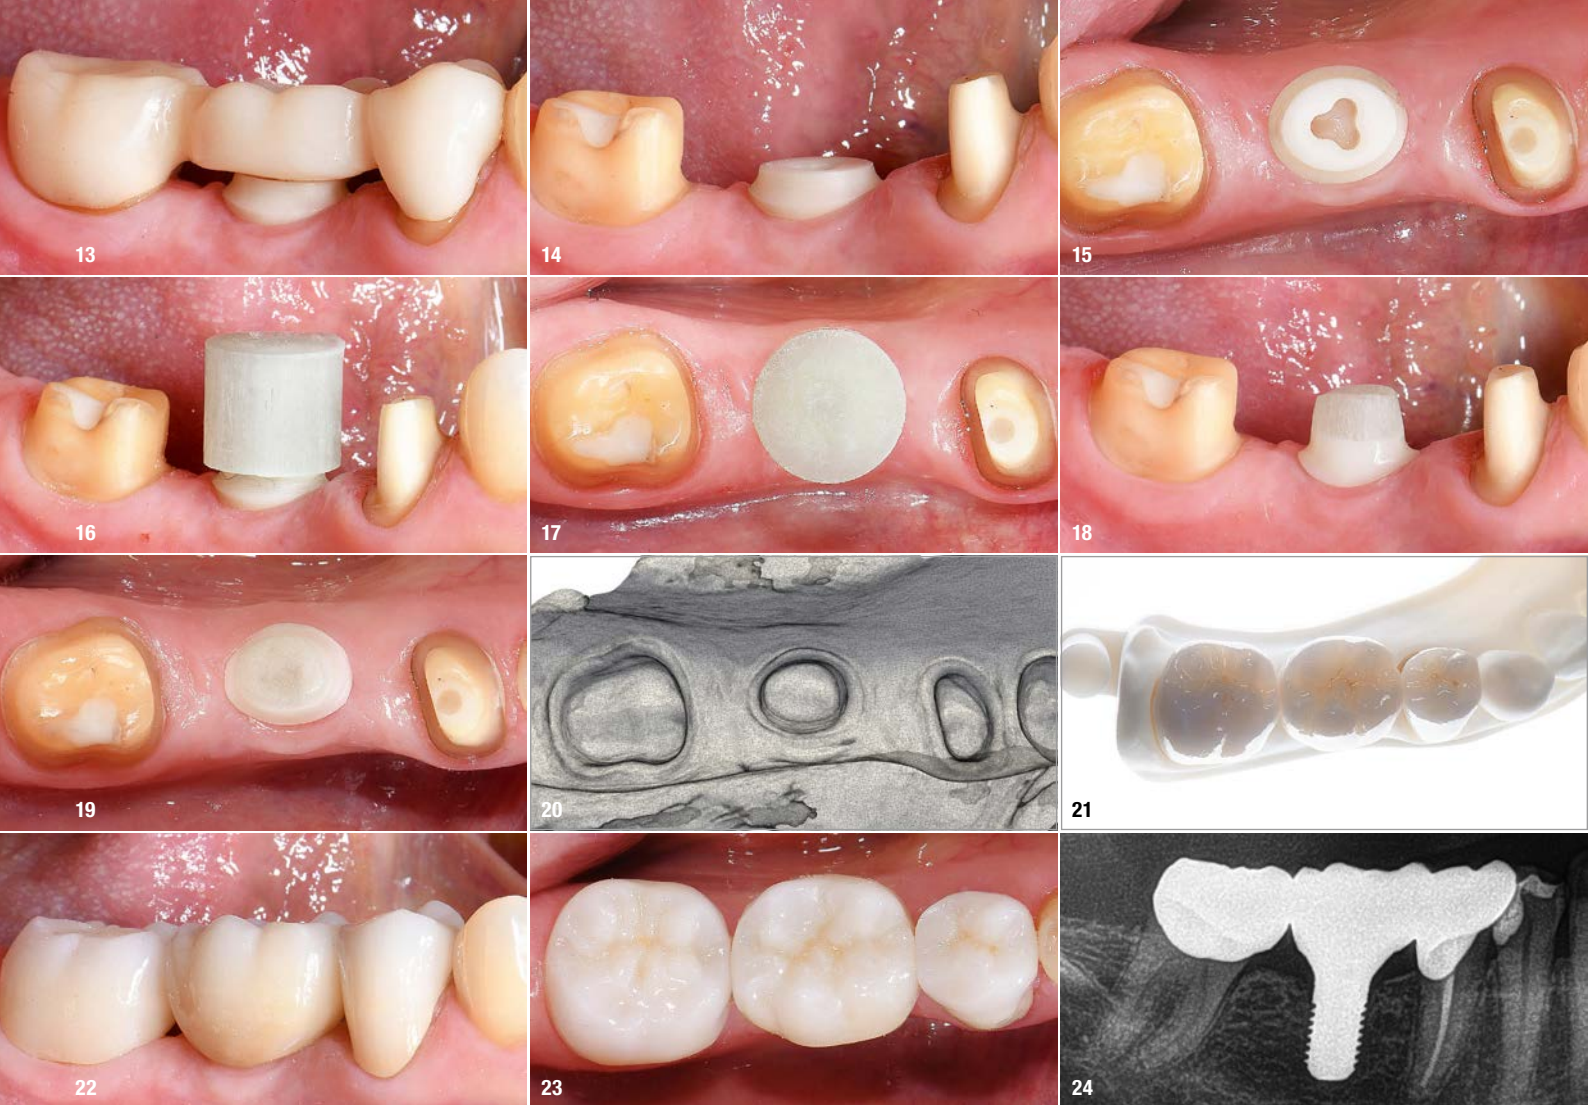
**Fig. 13:** Clinical situation three months after implant placement. Healing was uneventful. **Fig. 14:** The implant was stable and the soft tissue presented itself as healthy. **Fig. 15:** Occlusal view. **Fig. 16:** For the prosthetic reconstruction a glass fibre post and core assembly was adhesively cemented on the implant. **Fig. 17:** The post and core assembly is pre-fabricated and tightly fits into the implant connection. **Fig. 18:** Following this build-up, the implant was prepared for a full-crown restoration just like a natural tooth. **Fig. 19:** Occlusal view. **Fig. 20:** An intra-oral scan was performed for a lab-side prosthetic workflow. **Fig. 21:** Three monolithic zirconia crowns were fabricated (Ceramics: MDT Claus-Peter Schulz). **Fig. 22:** Intra-oral view of the treatment result. **Fig. 23:** Occlusal view. **Fig. 24:** Radiographic evaluation of the treatment result.

The prosthetic phase was commenced three months after implant placement. The provisional restoration was removed and final preparations performed on the abutment teeth. Following an uneventful healing phase, the implant was stable and the periimplant soft tissue healthy (Figs. 13–15). For the prosthetic reconstruction a glass fibre post and core assembly was adhesively cemented on the implant (Figs. 16 & 17). The post and core assembly is pre-fabricated and tightly fits into the implant connection. Following this build-up, the implant was prepared for a full-crown restoration just like a natural tooth (Figs. 18 & 19). An intra-oral scan was performed and three monolithic zirconia crowns fabricated using a lab-side workflow (Figs. 20 & 21; Ceramics: MDT Claus-Peter Schulz). The final restorations were cemented. Figures 22 to 24 show the final treatment result.
